# Dispersal of microplastic from a modern artificial turf pitch with preventive measures

- Case study Bergaviks IP, Kalmar

Status: Report

Kalmar kommun

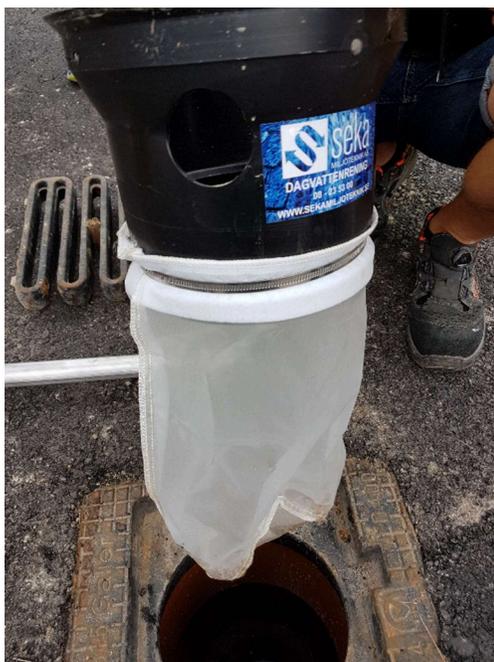
Figure 3. Granulate trap at Bergaviks IP

- Granulate traps were installed in all stormwater drains around the pitch (>200  $\mu\text{m}$ ), figure 3 below
  - Enable measurement of microplastic > 200  $\mu\text{m}$  which reaches the open stormwater drains and is captured in the granulate traps

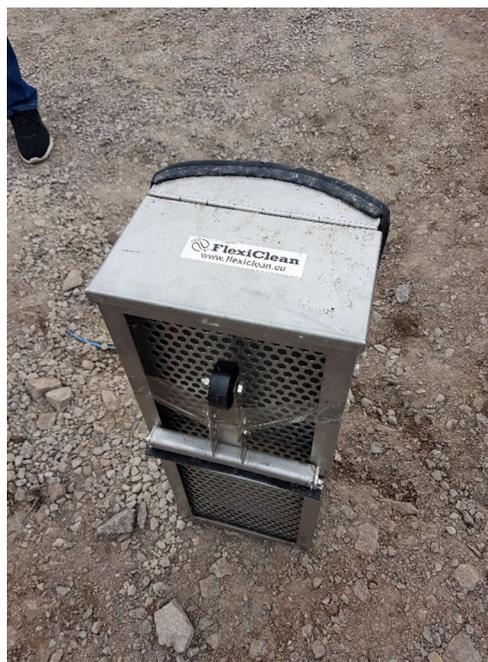
Figure 4. Granulate filter before installation in drain at Bergaviks IP

- Granulate filter which captures microplastic > 100  $\mu\text{m}$ , figure 4 above
  - Prevents microplastic > 100  $\mu\text{m}$  being dispersed with the surface water
- Winter lining to pile up snow on the pitch instead of hard surface
  - Minimise the spread of granulate from the pitch as a result of snow clearing
- Fence around the entire pitch with a board at the bottom against the ground
  - Minimise dispersal outside the fence along the ground

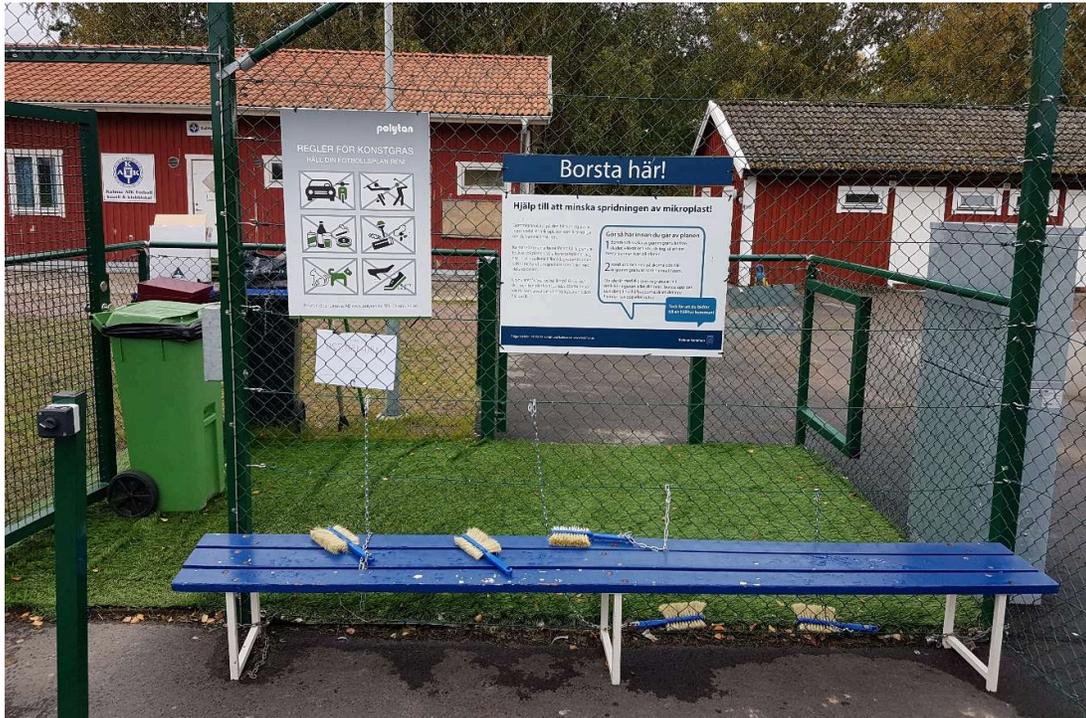
Figure 5. Brushing station with info sign at entrance/exit of Bergaviks IP

- A main entrance/exit with brushing station and information sign for players, figure 4 below.
  - Direct players to the exit and there prevent microplastics being spread from the pitch with players
